## CLARK FIRE EXPERT DISCLOSURE REPORT

**WILLIAM JEROME RUTH, INDIVIDUALLY,  
AND AS WRONGFUL DEATH REPRESENTATIVE OF  
THE ESTATE OF CYNTHIA SHOOK RUTH**

**UNITED STATES DISTRICT COURT  
FOR THE DISTRICT OF WYOMING**

**CIVIL ACTION NO.: 22-CV-230**

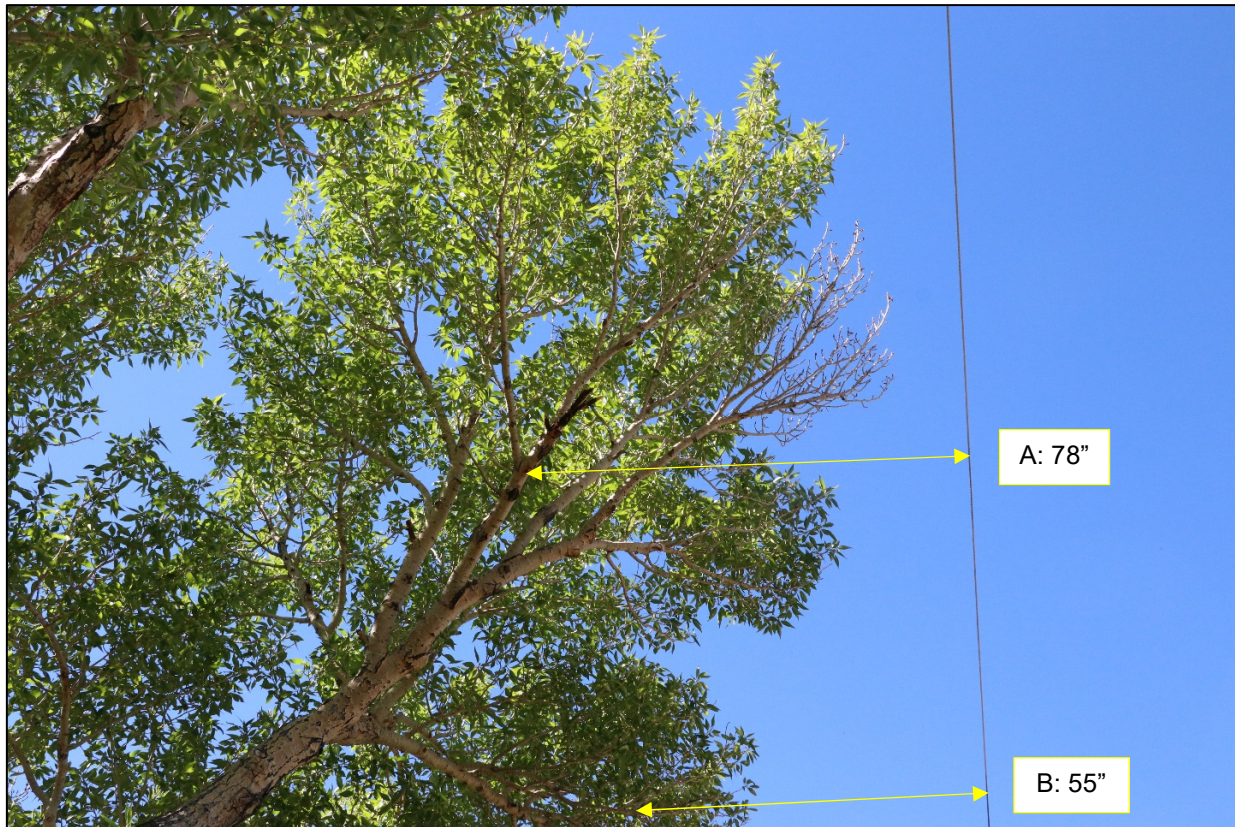
**Figure 8 - Crown of the subject tree, showing the branch without leaves and measurements A and B.**

4. A broken and burned portion of branch was found on the side of the subject tree facing the distribution line, as shown in Figure 8, measurement A. The distance between the base of this portion of branch<sup>20</sup> and the phase conductor of the distribution line was measured to be approximately 6 feet and 6 inches (78 inches) with a measuring tape.

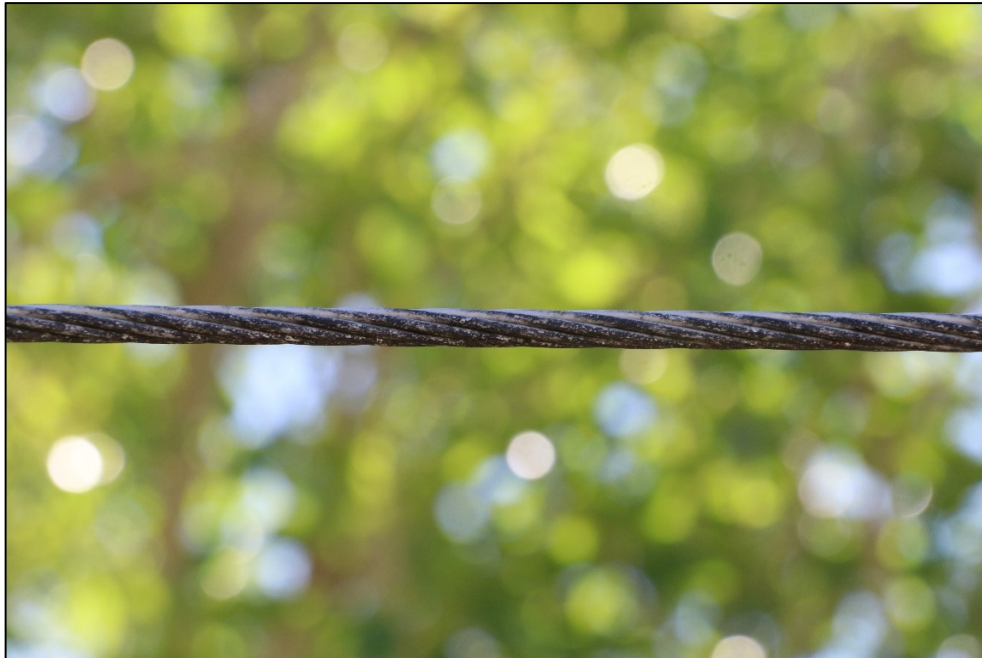
**Photograph 6 - Phase conductor with discoloration. Subject tree in background.**

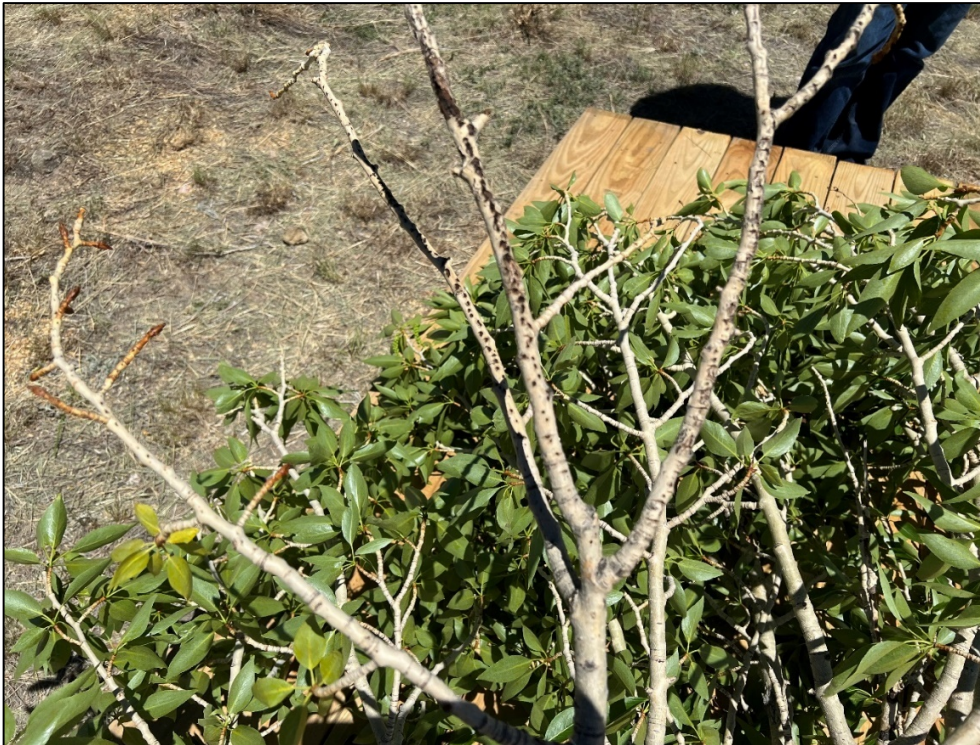
**Photograph 8 - Close up of evidence item E-9 which exhibits burned areas due to arc tracking. Photograph by Eric Black, IMG\_7956.**

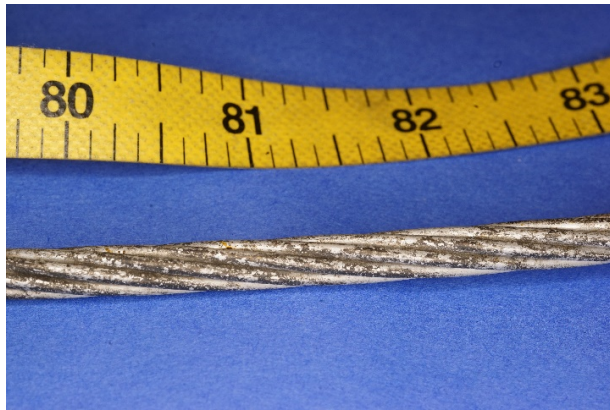
1. Discoloration was found on the distribution conductor sections that were originally located near the subject tree. This discoloration was not found on sections that were originally located farther north and south on the line.
2. Resinous material was found on the conductor section labeled Item #3.01. This material was amber in color and appeared to be solidified fluid deposit on the surface of the conductor section. See Photograph 11 and Photograph 12 below.

**Photograph 11 – Portion of line conductor Item 3.01 with soot deposits on the conductor.**

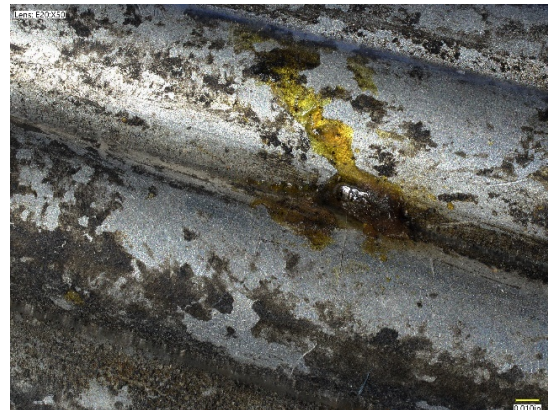
**Photograph 12 - Microscopy of Item 3.01 with resin deposit on the conductor. Resin material was noted in a number of locations on the conductor in the area where it was adjacent to the subject tree.**

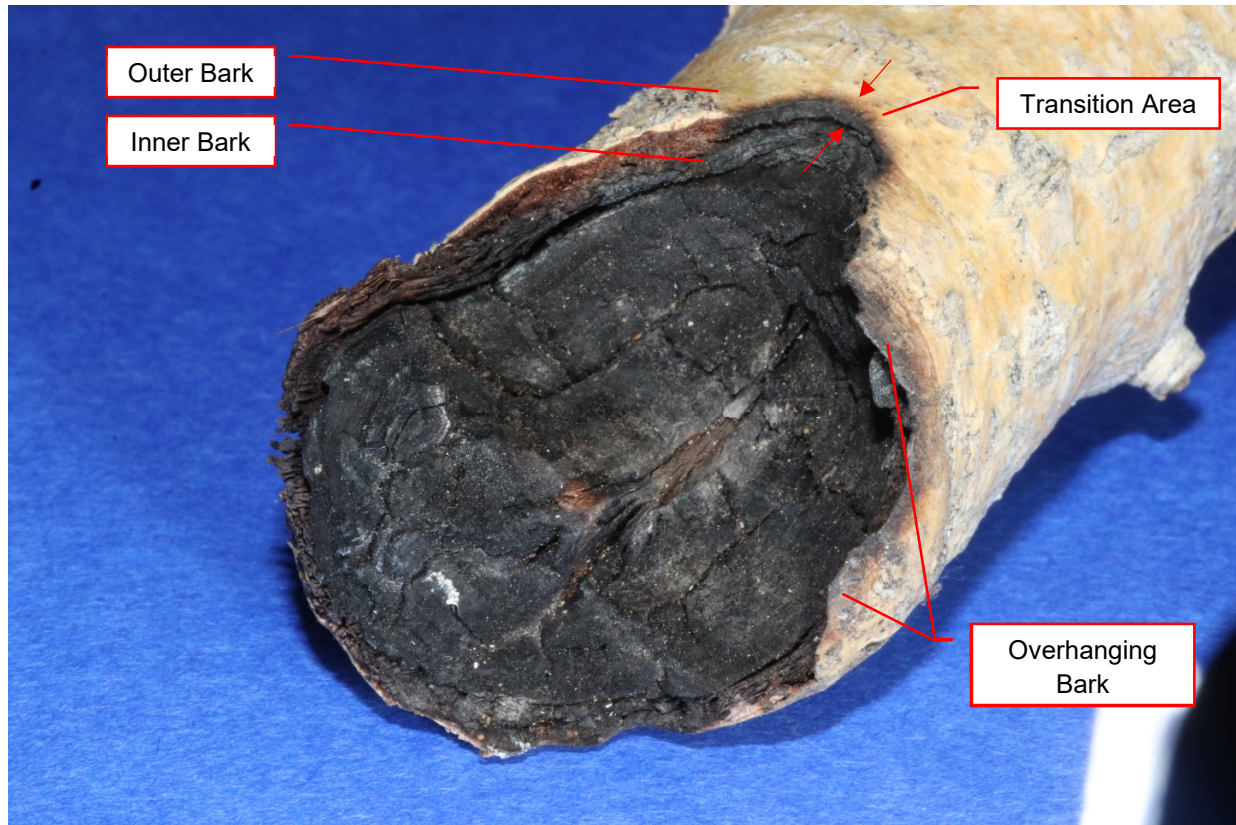
3. The base end of Item #1 (E-1) showed signs of charring and burning through its entire diameter. The outer bark in the area showed a very narrow transition zone between portions that were unaffected by heat, areas that were discolored due to heat, and finally the area that had been fully consumed. There were areas along the circumference where the inner bark showed more damage than the outer bark. In some areas, the inner bark and wood had been completely consumed leaving an overhanging portion of outer bark. (See Figure 10.)

**Figure 10 - Burnt end of Item #1 with callouts showing burn transition areas and overhanging outer bark.<sup>22</sup>**

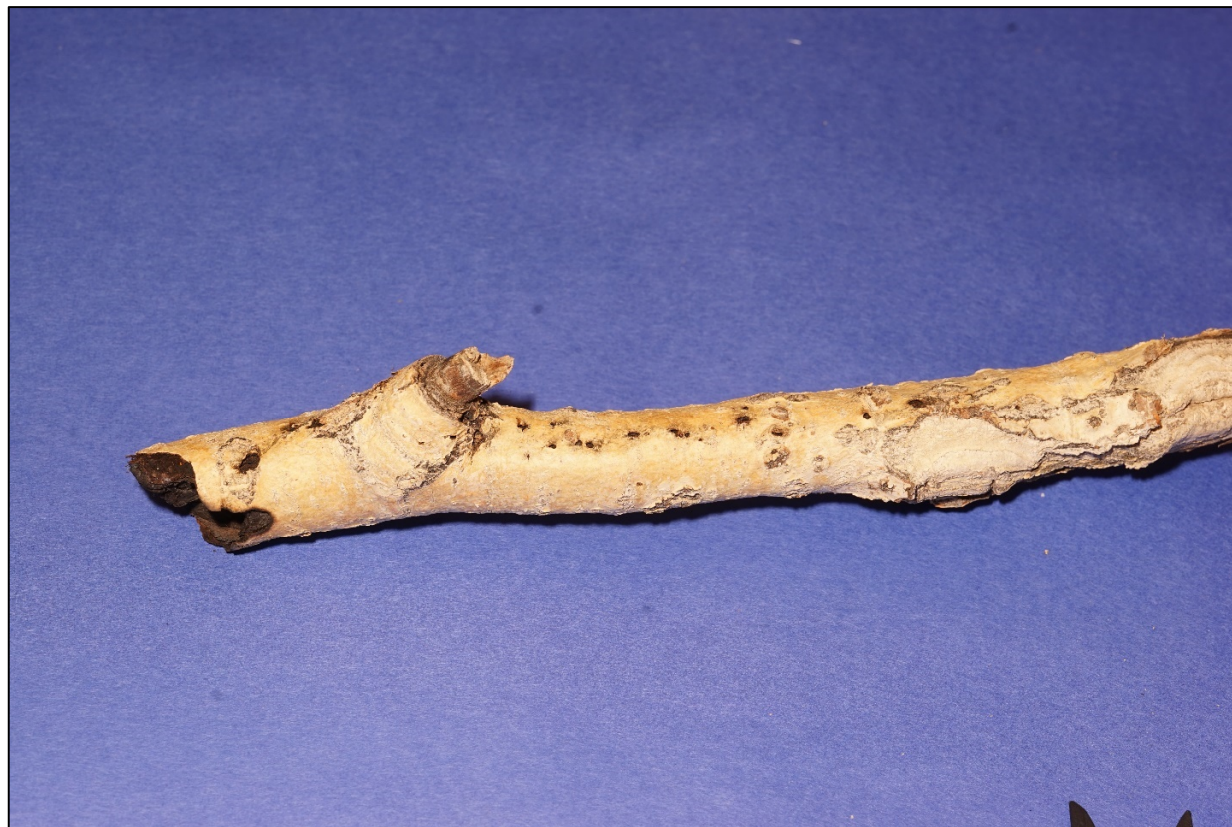
4. Item #1 had a series of small holes that ran longitudinally along the base end of the branch as shown in Photograph 13. The perimeters of these holes were similar to the end of the branch in that the outer bark in the area had a sharp transition between unaffected material and material that was missing. Many of the holes had discolorations around portions of the perimeter in a seemingly directional pattern.

**Photograph 13 - Basal end of Item #1 showing longitudinal holes in the bark.**

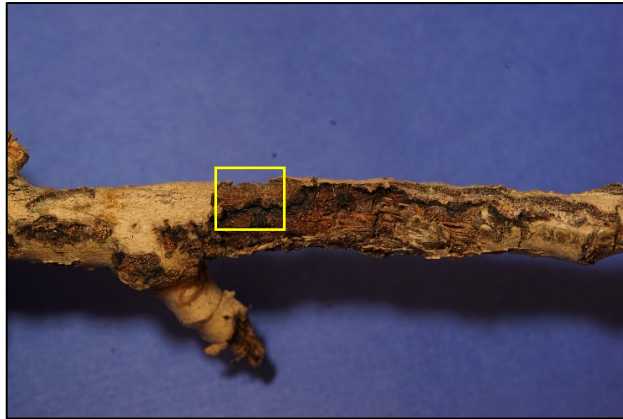
1. Item #9 had a number of small limbs that had patterns of dark spots that ran longitudinally to the limb. These limbs were cut from the branch and marked as Items #9.01, 9.02, and 9.03. The markings were consistent in appearance with markings found on Item #1.
2. In addition to the small circular markings that were found running longitudinally, Item #9.01 showed a linear path of discoloration on its exterior. In addition to the discoloration, the pattern ran as a furrow in the exposed inner bark of the limb. The woody material within the furrow appeared to be pyrolyzed wood.

**Photograph 14 - Linear pattern on Item #9.01 with callout for Photograph 15**

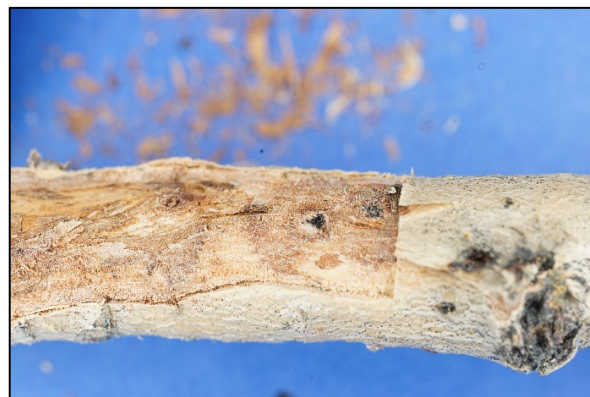
3. Samples of material within the discolored areas of Item #9.01 were taken for SEM imagery and marked as Items #9.0101, 9.0102, and 9.0103.
4. A portion of bark with circular black marks near the basal end of Item #9.01 was cut and peeled away from the interior portions of the limb. With the outer bark peeled away, the black marks on the interior layers of the limb were exposed. The markings appeared as discolored divots that extended deeper into the vascular layer of the limb. See Photograph 16 and Photograph 17.

**Photograph 17 - Detail of markings on the interior layers of Item #9.01**

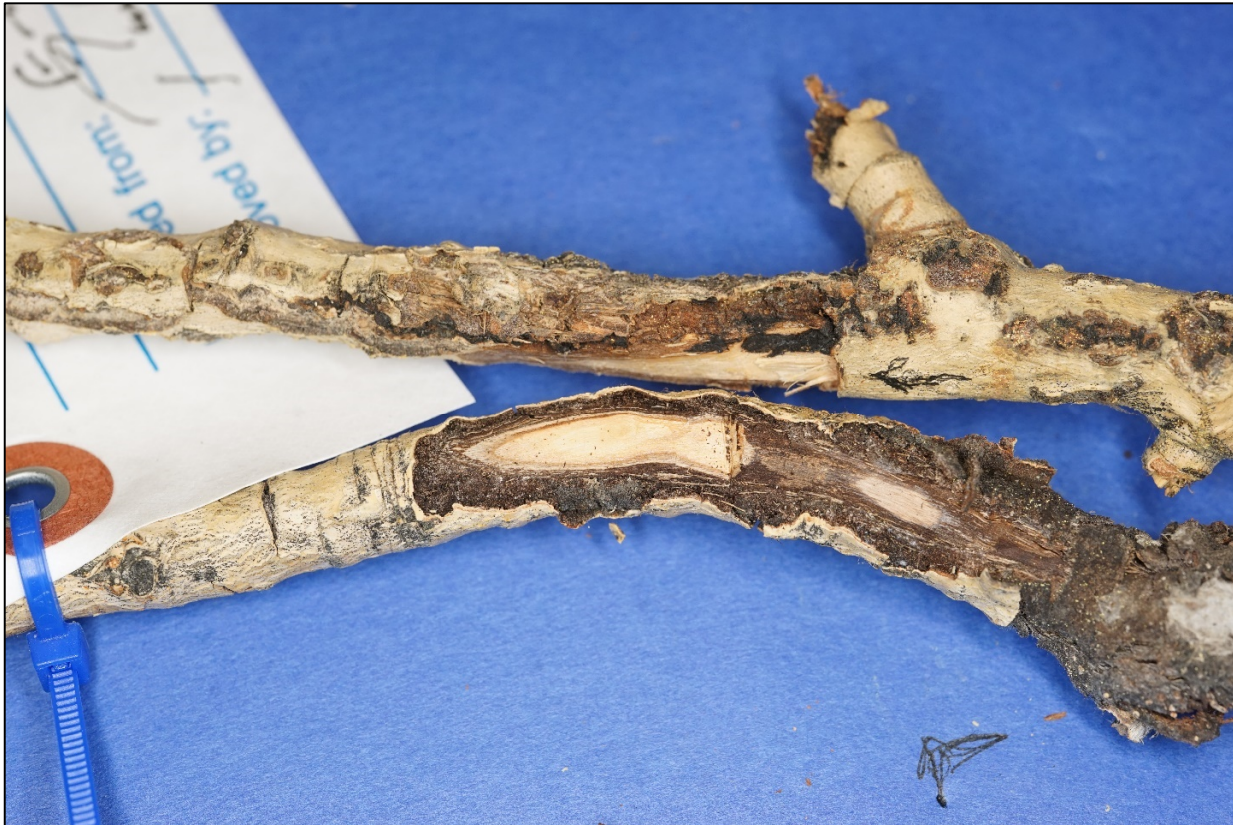
6. Item #9.06 was cut from the main branches. The base of Item #9.06 had an area where the outer papery bark had split away exposing a darker portion of inner bark. This area was cut in the same manner as Item #9.01 to expose the layers between bark and inner tissue. The markings on Item #9.01 appeared to be darker than anything seen on the exposed portion of #9.06 (Photograph 20).

Photograph 20 - Item #9.01 (upper) next to Item #9.06 (lower)

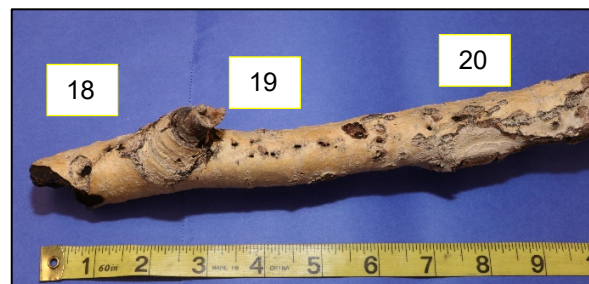
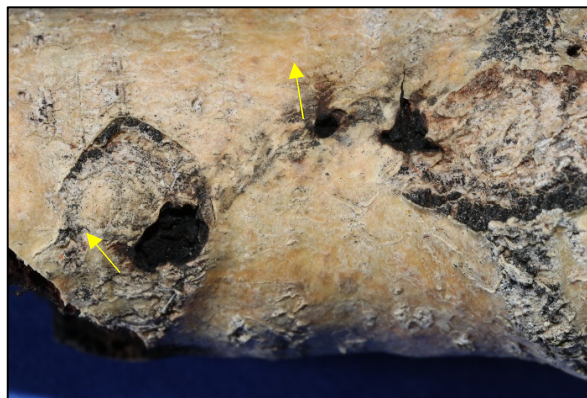
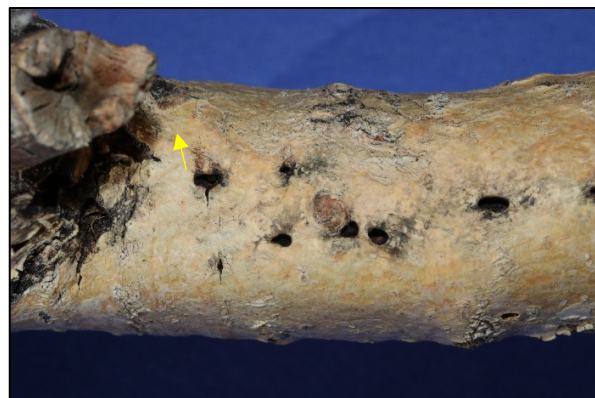
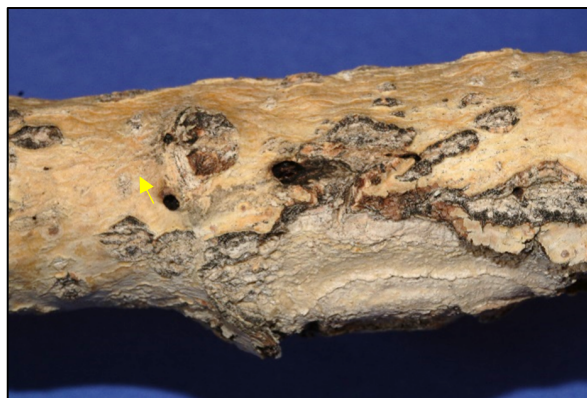
2. Areas near the basal end of Item #1 that showed roughly circular holes in the outer bark with blackened material beneath also showed areas of discoloration that extended radially from the holes in the outer bark. This radial discoloration appeared to extend in a consistent direction wherever it appeared along the branch. See Photograph 27 through Photograph 30.

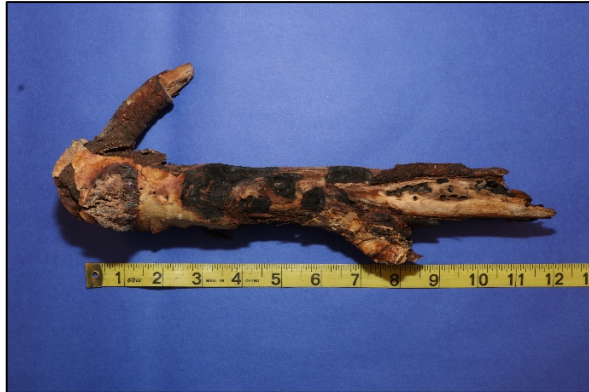
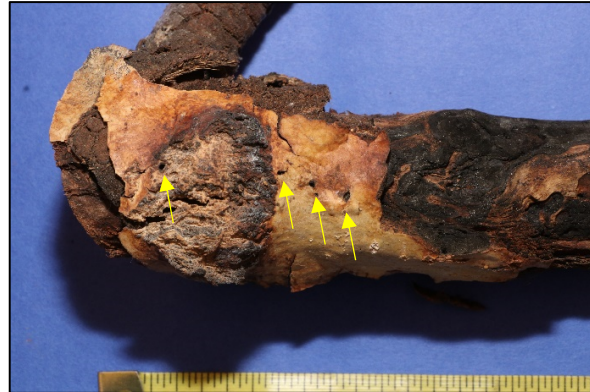
3. The burnt branch stump on Item #11 was cut from the rest of the branch and marked as Item #11.01. The portion of burnt branch showed significant signs of burning with multiple areas of charred wood along its length and circumference. Small circular holes, consistent with those found on Item #1, were found near the base of the limb in close proximity to an area of charring. See Photograph 31 and Photograph 32.

**Photograph 32 - Detail of Item #11.01 showing circular holes near the base.**

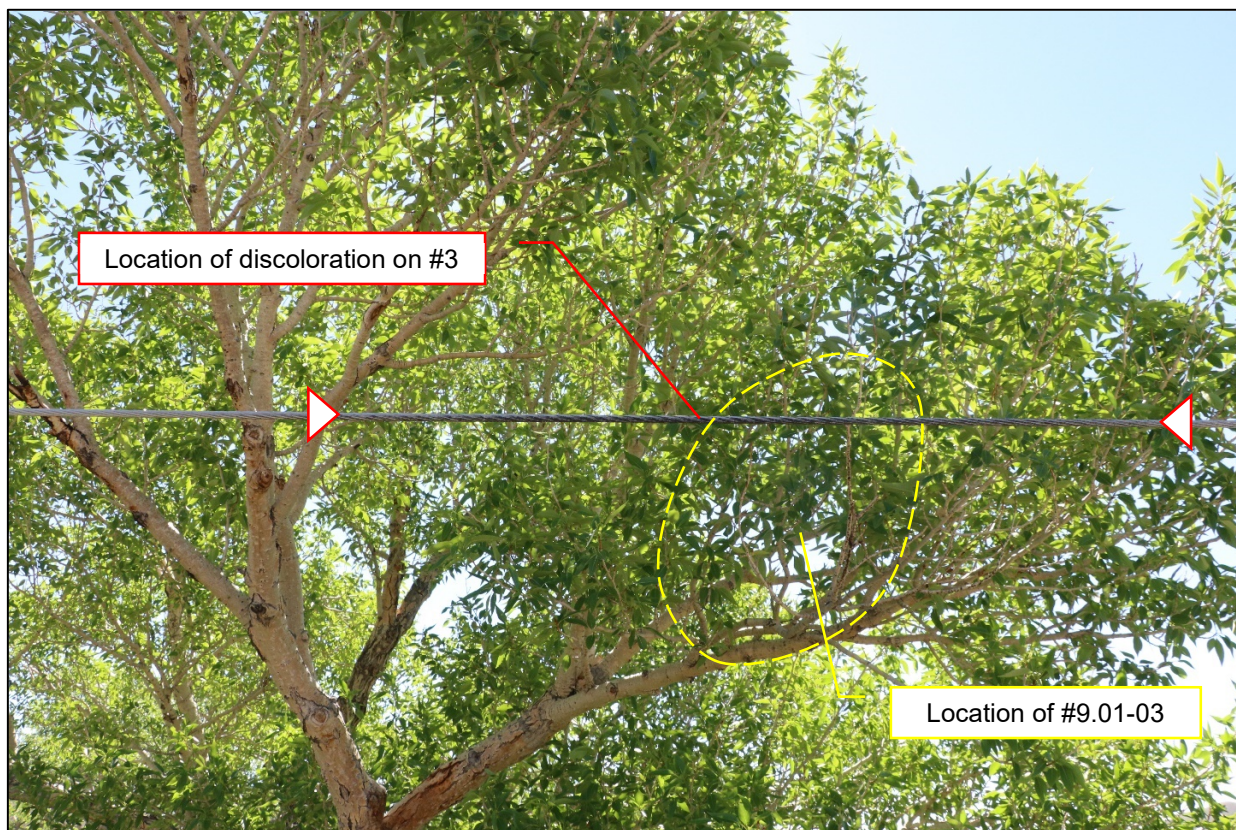
The discoloration on Item #3 is most likely the result of the deposition of soot and smoke, including the condensation of wood tars and other pyrolyzed aerosols. These depositions were found only on portions of the distribution line that were in relatively close proximity to the subject tree. Furthermore, these areas of discoloration coincided with burn indicators on the tree as shown in Figure 13 and Figure 14 below.

**Figure 13 – Area of discoloration on Item #3 in relation to Item #9.**

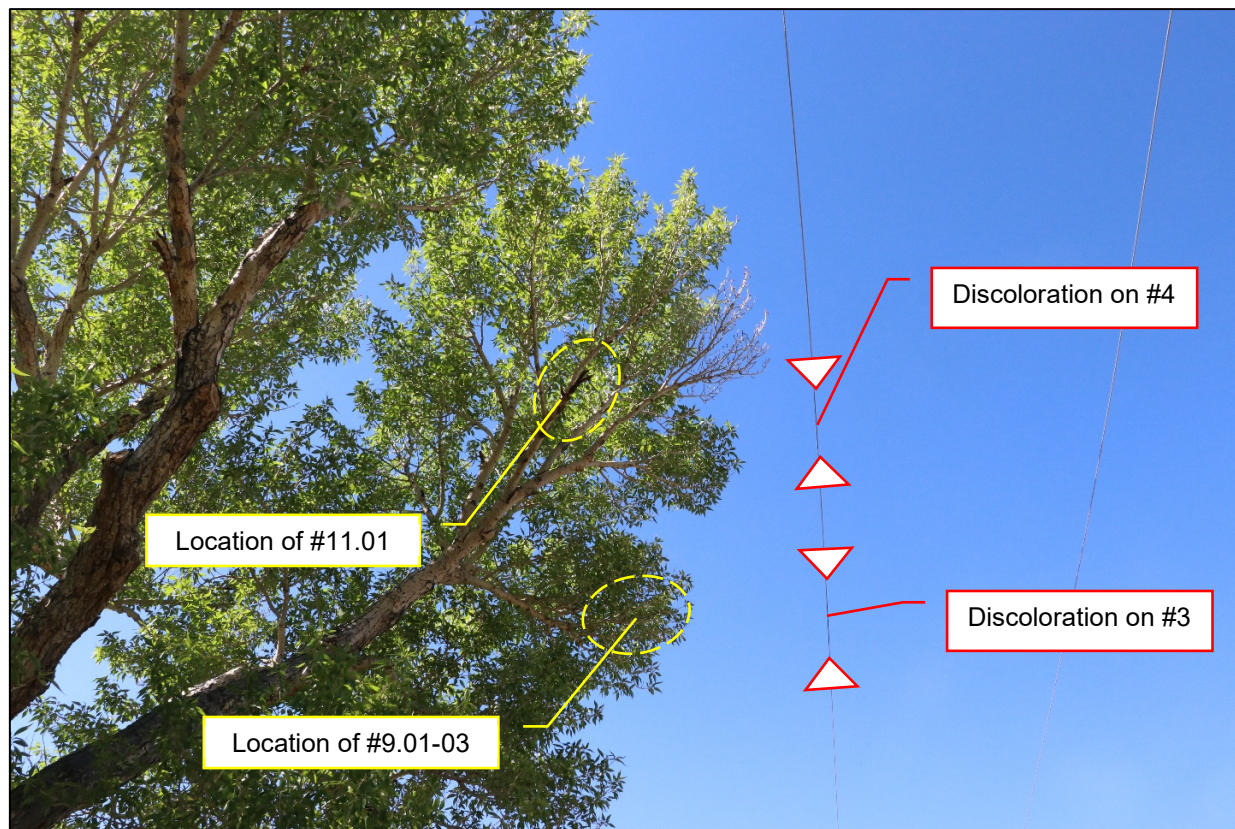
**Figure 14 - Locations of line discoloration in relation to burn indicators on the subject tree.**

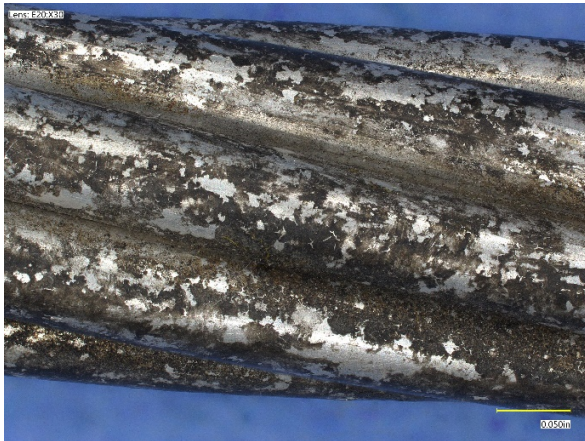
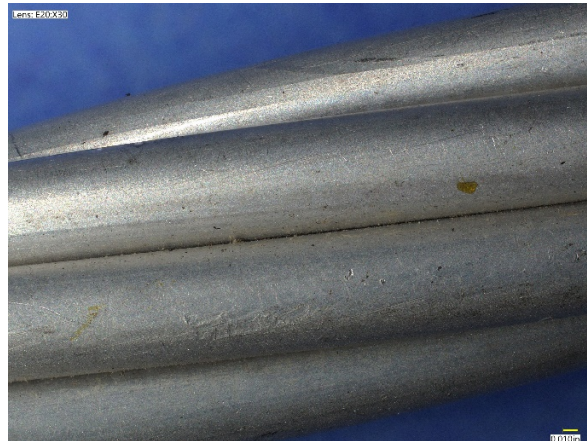
Photograph 33 and Photograph 34 show the visual differences between sections of conductor that likely came into direct contact with portions of the crown of the subject tree. It is apparent that the discoloration is not a result of some macro-scale phenomenon that would affect the conductor as a whole. The only difference between a section that appeared similar to Photograph 33 and a section that appeared similar to Photograph 34 would be its proximity to nearby vegetation. Given that the nearby sections of vegetation show signs of burning, it is reasonable to conclude that the discoloration on the line is related to the burn indicators on the vegetation.

**Photograph 33 - Detail of conductor segment #3.01 with discoloration.**

**Photograph 34 - Detail of conductor segment #3.01 without discoloration.**

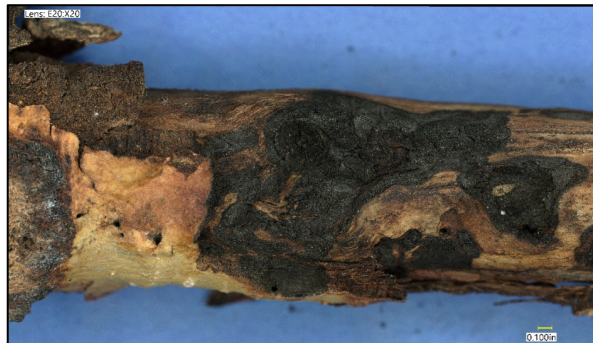
As stated, Items #1, 9, and 11 also showed signs of contact with the nearby distribution line in the form of burn indicators on their branches and limbs. These burn indicators were found in two general types of artifacts. The first type of artifact found was bulk portions of charred and pyrolyzed wood (Photograph 35), and the second type of artifact took the form of a series of small, generally circular, markings that ran longitudinally in a series along its limb or twig (Photograph 36).

**Photograph 35 - Area of #11.01 showing charring.**

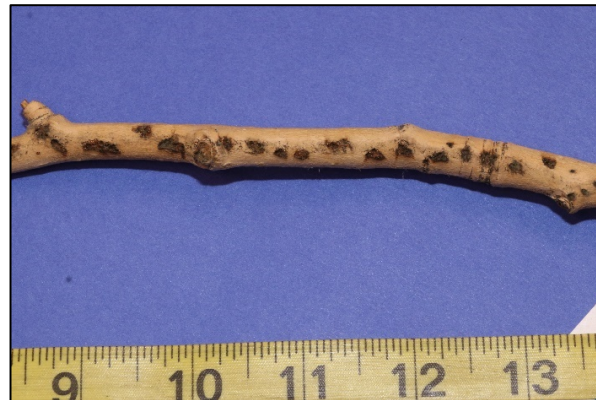
**Photograph 36 - Area of #9.02 showing a longitudinal series of circular markings.**

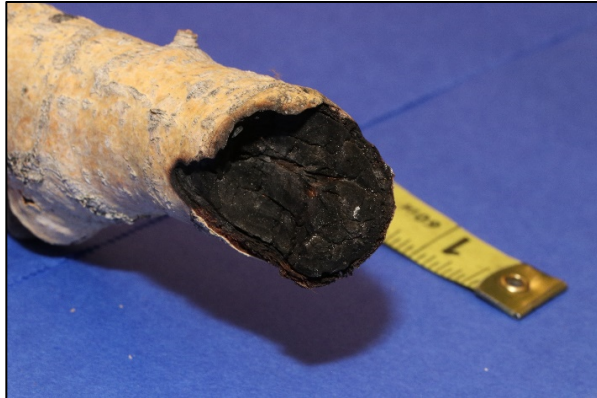
The bulk portions of charred wood are readily identifiable to anyone who has seen a campfire. These artifacts were found on the basal end of Item #1 (E-1), as shown in Photograph 37 and on multiple points along Item #11.01, as shown in Photograph 38.

**Photograph 37 - Charred area on Item #1.**

Although Item #1 was found on the ground downwind of the subject tree, the burning that occurred at its base could only have been caused by contact with the distribution line. The branch was found in an area that had no other burning, as shown in Figure 15 and Figure 16. The branch obviously traveled to its location on the ground after it began to burn. Since there were no other signs of burning between E-1 and the crown of the subject tree, it can be determined that E-1 originated at the subject tree. As with Item #11.01, there are no other competent ignition sources available to initiate burning in the crown of the tree other than the nearby distribution line.

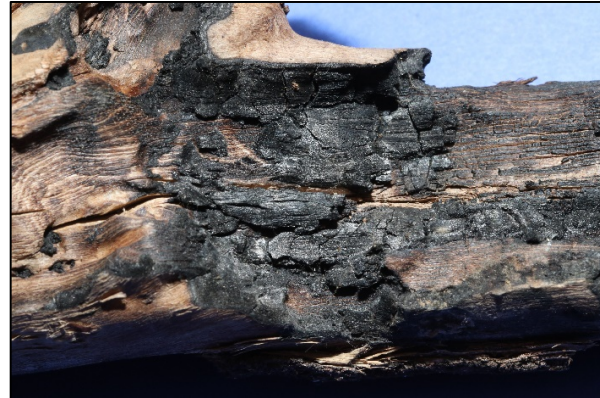
**Photograph 38 - One of multiple charred areas on Item #11.01.**

In the case of Item #11.01, there are no other competent sources of ignition in or around its location within branch E-11. According to LiDAR scans of the area, the closest point of burning associated with the Clark Fire was approximately 140 feet downwind to the east.<sup>33</sup> As there were no reports of lightning in the area at the time of the fire, the only nearby competent source of ignition was the BEC distribution line. As stated above, the portion of line in proximity to Item #11.01 showed discoloration from the contact that occurred.

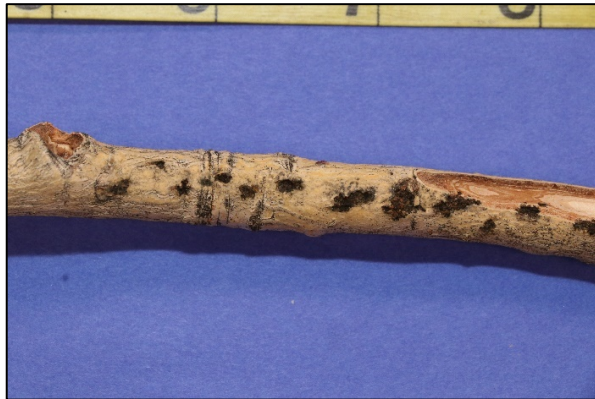
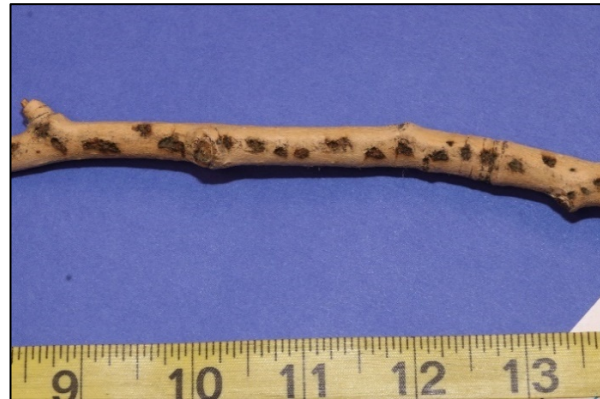
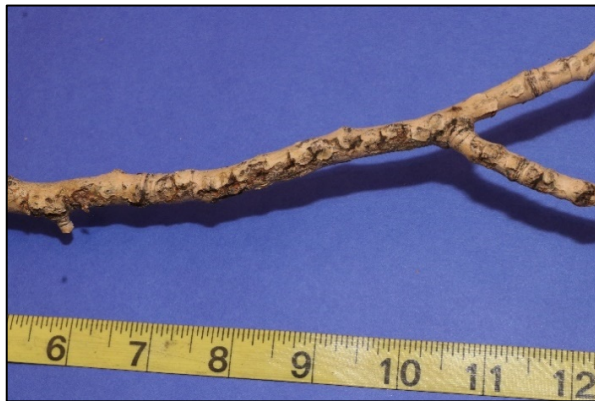
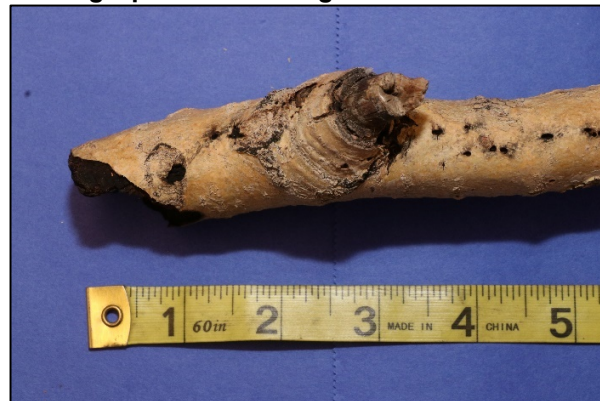
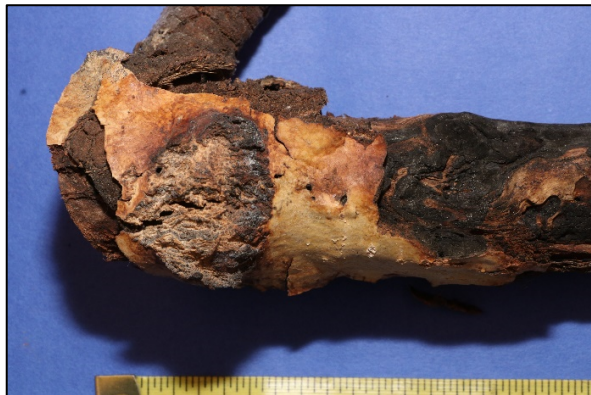
The second type of indication that the crown of the subject tree came into contact with the distribution line was a series of small, generally circular, markings that ran longitudinally along its respective limb or branch. This type of indication was seen on Items #1, #9.01, #9.02, #9.03, and #11.01, as seen in Photograph 39 through Photograph 43.

The series of longitudinal circular markings were found on branches E-9 and E-11 within the crown of the tree. Except for some inconclusively similar spots on E-10, no other branch was found on the subject tree with these markings. The areas on E-9 and E-11 where these markings were found were all measured to be within the 10-foot ROW of the distribution line.

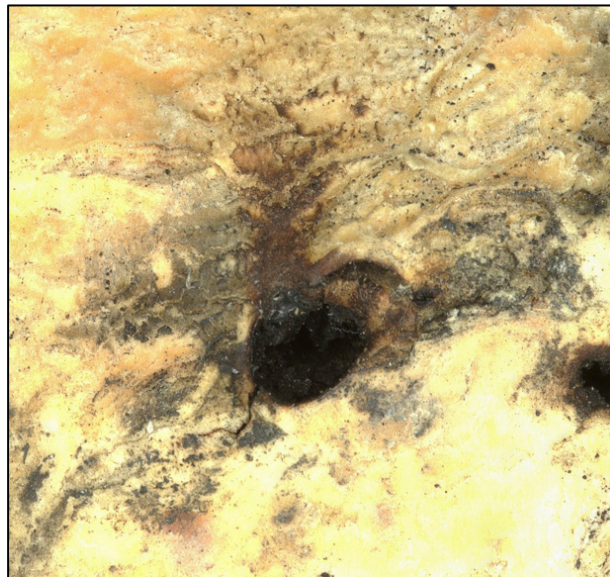
As noted in the observations from the July 27, 2023, evidence inspection, some of the holes found in Item #1 appeared to have pattern of discoloration that extended radially from the perimeter of the hole in the outer bark. Of the four radial patterns that were found on Item #1, each area of discoloration extended from its respective hole in a direction within approximately 45 degrees of the others. This directionality appears to be consistent with the escape of gasses into a uniform wind field. The discoloration may be the deposition of condensed vapors, or it may be the result of hot gasses discoloring the outer bark itself.

**Figure 18 - Hole in the outer bark of Item #1 showing a radial pattern of discoloration.**

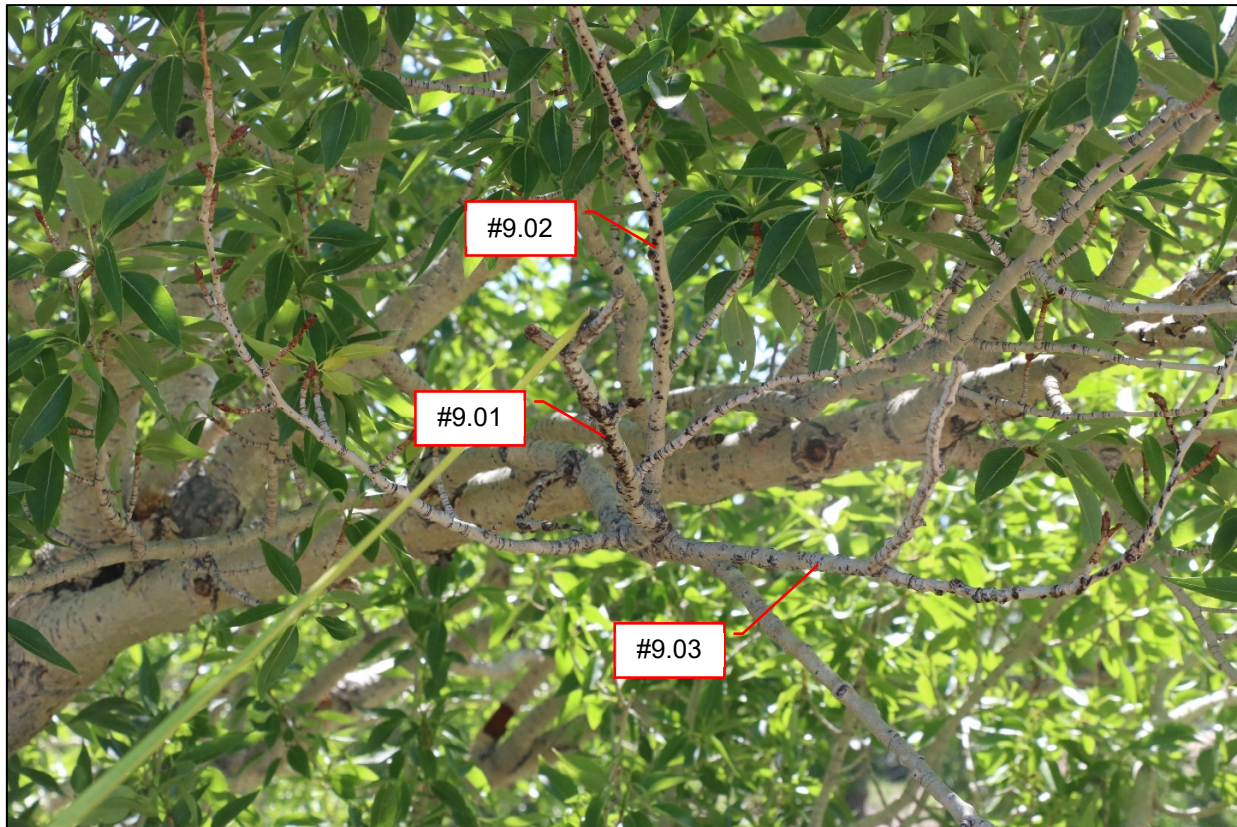
Furthermore, these markings were predominantly found on areas of potential contact if the limb or branch and the distribution line were brought together. This is shown in Figure 19, where the majority of the markings are in a location on their limb that would make contact if the parent branch were to move forward and down onto the nearby distribution line. The markings on Item #11.01 are also on the side of the branch that generally faces the distribution line.

A variation in this general pattern can be found on Item #9.02, which has a second series of markings that are located on the opposite site of the limb. This second pattern is located on an area that would make contact if the branch were to first pass the line downwards and then rebound.

**Figure 19 - Photo of Items #9.01, #9.02, and #9.03 from the perspective of the distribution line.**
